TURBOJET-ENGINE EVALUATION OF AISI 321 AND AISI 347

STAINLESS STEELS AS NOZZLE-BLADE MATERIALS

By Floyd B. Garrett and Charles Yaker

NACA RM E9K17

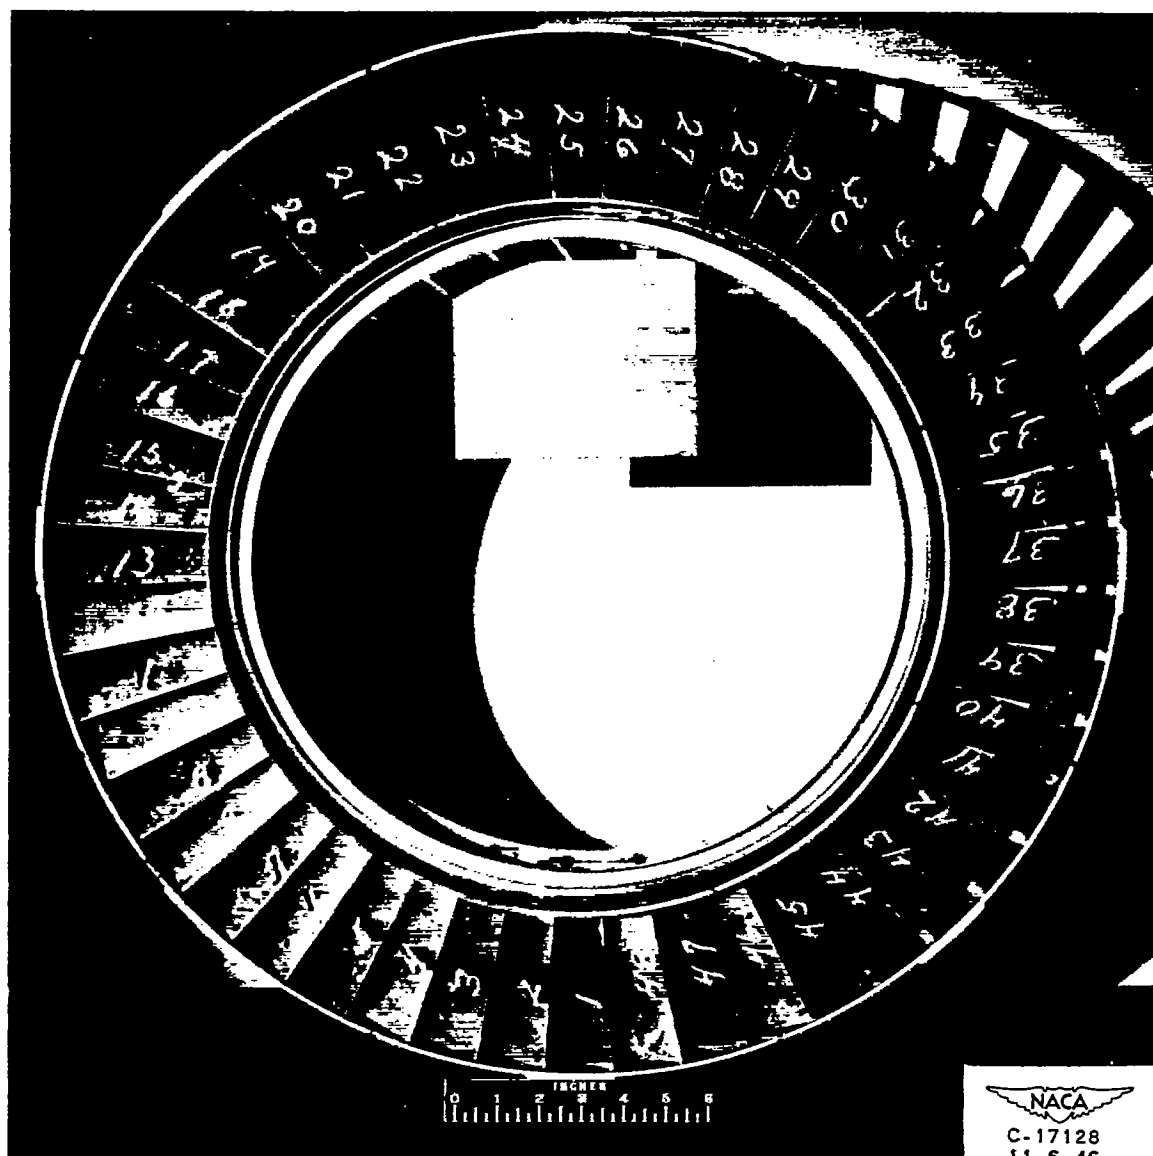
Figure 1. - Downstream face of nozzle diaphragm before engine operation.
